Contract #: 04-0120F4Cty: SF/ALA Rte: 80 PM: 13.2/13.9File #: 69.28**WELDING INSPECTION REPORT****Resident Engineer:**Siegenthaler, Peter**Address:** 333 Burma Road**City:** Oakland, CA 94607**Report No:** WIR-020761**Date Inspected:** 19-Feb-2011**Project Name:** SAS Superstructure**OSM Arrival Time:** 700**Prime Contractor:** American Bridge/Fluor Enterprises, a JV**OSM Departure Time:** 1900**Contractor:** Zhenhua Port Machinery Company, Ltd (ZPMC), Changxing Island **Location:** Shanghai, China**CWI Name:** Zho Zhong Hai**CWI Present:** Yes No**Inspected CWI report:** Yes No N/A**Rod Oven in Use:** Yes No N/A**Electrode to specification:** Yes No N/A**Weld Procedures Followed:** Yes No N/A**Qualified Welders:** Yes No N/A**Verified Joint Fit-up:** Yes No N/A**Approved Drawings:** Yes No N/A**Approved WPS:** Yes No N/A**Delayed / Cancelled:** Yes No N/A**Bridge No:** 34-0006**Component:** Orthotropic Box Girder( OBG)**Summary of Items Observed:**

**OBG # TRIAL ASSEMBLY YARD****WELDING:****Segment 12BE ~ 12CE**

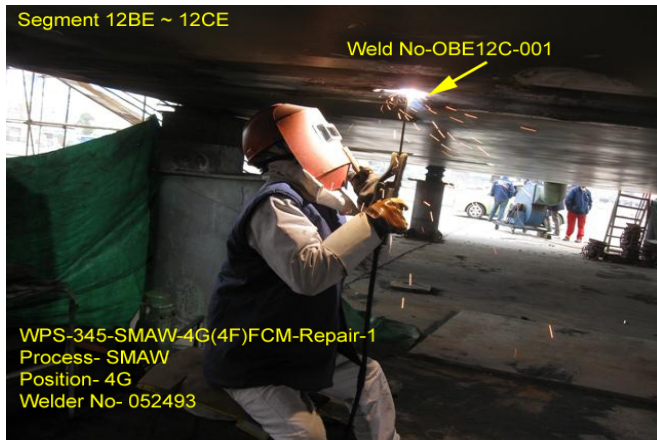
This QA Inspector observed ZPMC qualified welding personnel identified as 052493 perform Shielded Metal Arc Welding (SMAW), weld joint identified as OBE12C-001; located On Orthotropic Box Girder (OBG) Bottom Plate to Bottom Plate CJP Weld; ZPMC Quality Control (QC) is identified as Mr. Wang Li Yang. The Welding Repair Report (WRR) was B-WR20190 .This QA Inspector observed the base material appears to have been being preheated by an electrical heating element prior to welding. ZPMC Quality Control (QC) Mr. Wang Li Yang was onsite monitoring the welding variables. The welding variables recorded by QC appeared to comply with applicable WPS-345-SMAW-4G (4F) FCM-Repair-1. See attached photo for further details.

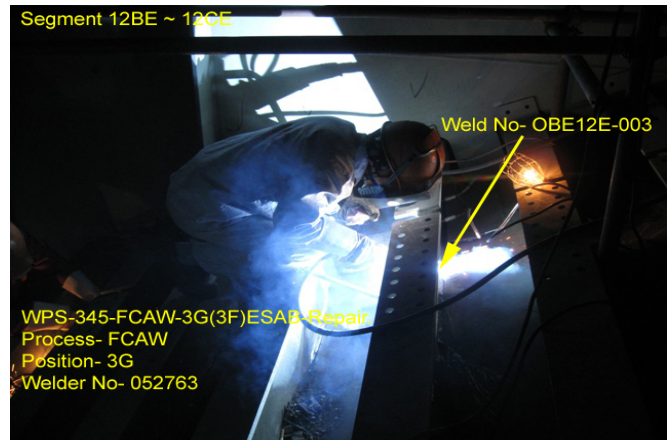
This QA Inspector observed ZPMC qualified welding personnel identified as 052763 perform Flux Cored Arc Welding (FCAW), weld joint identified as OBE12E-003; located On Orthotropic Box Girder (OBG) Side Plate to Side Plate CJP Weld; ZPMC Quality Control (QC) is identified as Mr. Wang Li Yang. The Welding Repair Report (WRR) was B-WR20185 .This QA Inspector observed the base material appears to have been being preheated by an electrical heating element prior to welding. ZPMC Quality Control (QC) Mr. Wang Li Yang was onsite monitoring the welding variables. The welding variables recorded by QC appeared to comply with applicable WPS-345-FCAW-3G (3F) ESAB-Repair. See attached photo for further details.
